**LETTER REPORT  
FOR  
FORMER ARCO REFINERY AND CHEMICAL RESEARCH FACILITY  
HARVEY, COOK COUNTY, ILLINOIS**

Date Prepared	27 February 2003
TDD Number	S05-0204-007
Analytical TDD Number	S05-0204-008
Document Control Number	249-2A-ACQE
Contract Number	68-W-00-119
START Project Manager	Ronald Bugg
Telephone No.	(312) 424-3305
U.S. EPA On-Scene Coordinator	Brad Benning

Subject: Site Assessment Letter Report, Draft  
Former ARCO Refinery and Chemical Research Facility  
210 147<sup>th</sup> Street  
Harvey, Cook County, Illinois

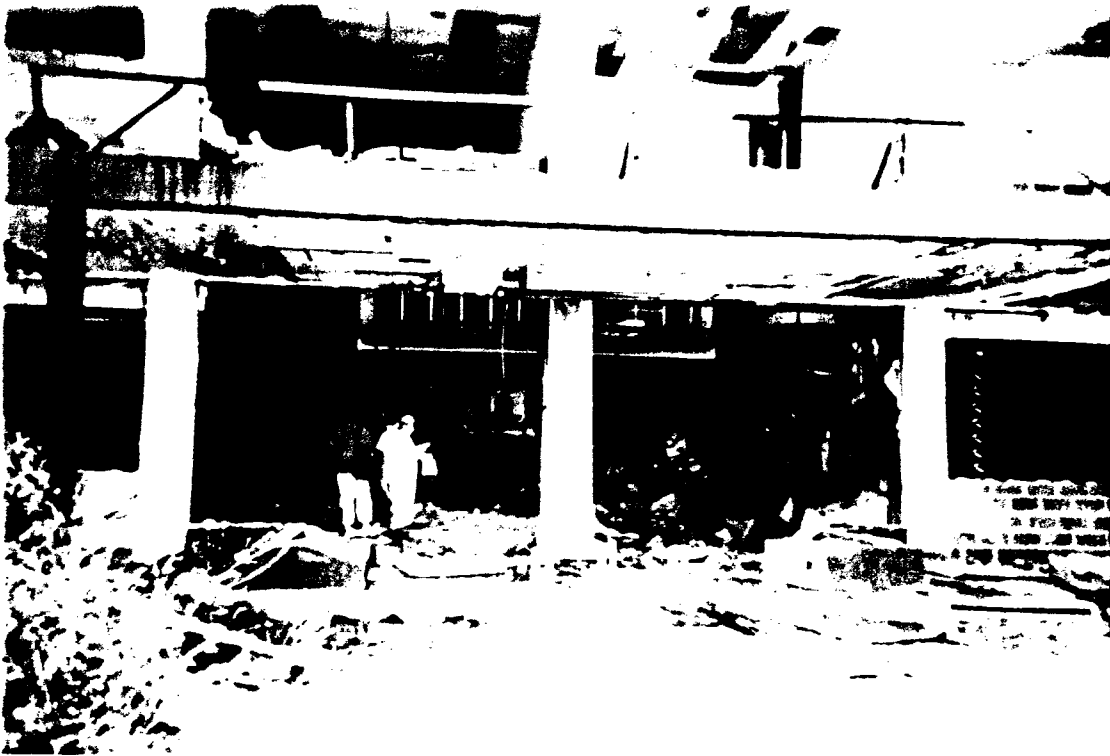
Site: ARCO Research Center  
 W.O. #: 12634.001.001.0249  
 Subject: Center of Main building, exterior windows vandalized, damaged asbestos, pipe insulation.

Evidence of vandalism on site was extensive. The main building consisted of three stories of offices, laboratory areas, storage areas, boiler rooms and a dinning area that contained a kitchen. All entrances to the main building and most of the windows were unlocked and had been vandalized. Vandalism on the main floor included areas in the hallways and several rooms where fires had been set. The second floor of the main building consisted of laboratories and additional office space which had been vandalized. Office spaces and meeting rooms occupied the third floor where windows and parts of the exterior walls had been removed by vandals. In general, the interior surfaces of the main building were extensively damaged by what appeared to be the removal of recyclable material from the facility. Insulation and debris were scattered on floors throughout the building.

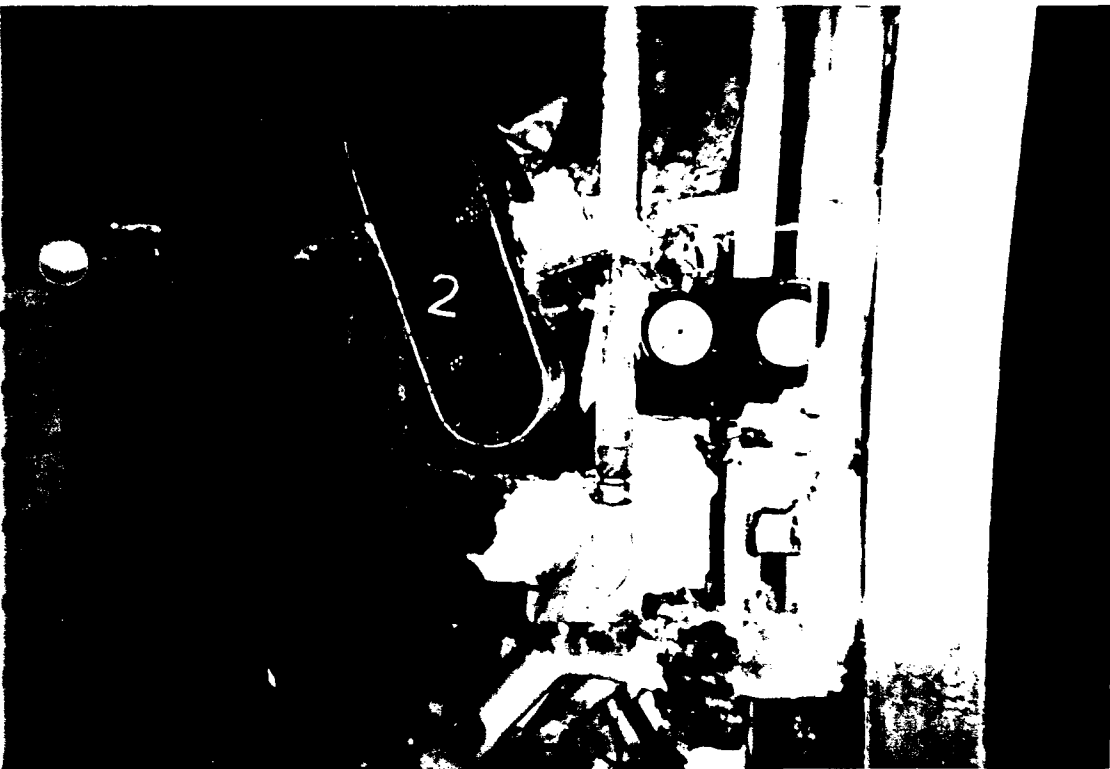
Site: ARCO Research Center  
 W.O. #: 12634.001.001.0249  
 Subject: Damaged pipe and duct insulation at supply fan.

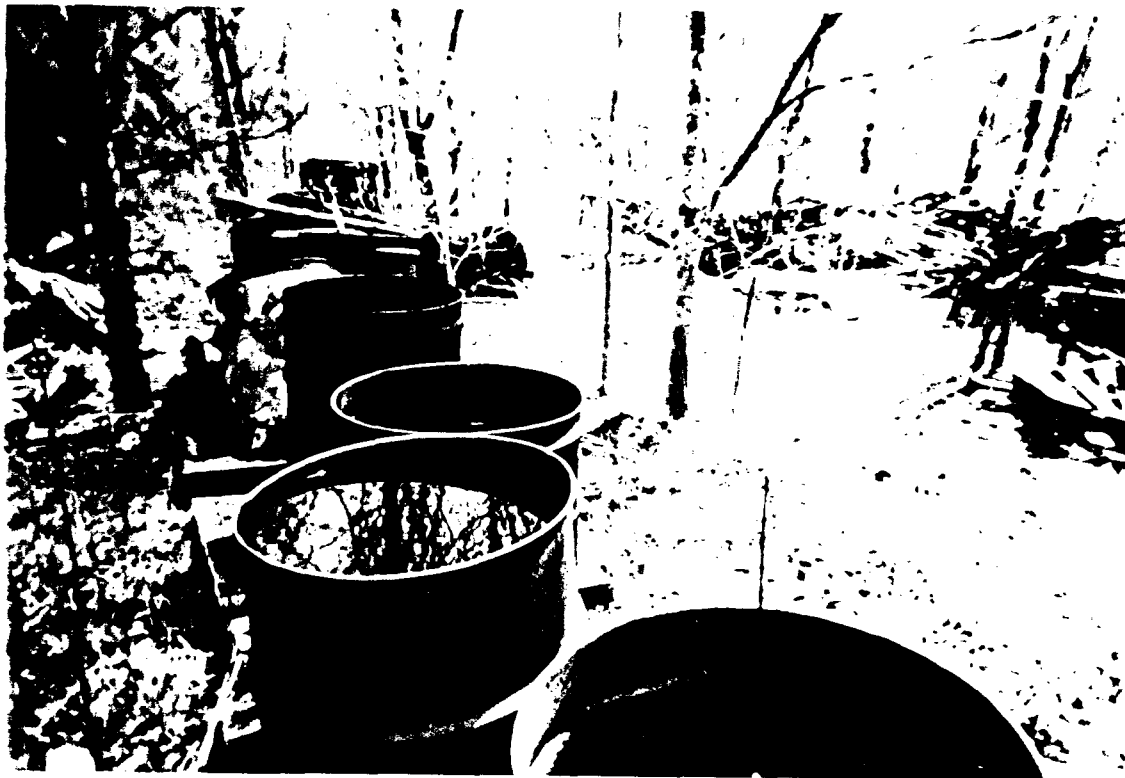
**Site:** ARCO Research Center  
**W.O.#:** 12634.001.001.0249  
**Subject:** Open top drums on the southend of the property (near DrumStorage)

The main building area of the site was not fenced in, but the remaining area of the site was fenced in and locked. Open, deteriorating drums of waste products and unknowns, possibly waste oil, were improperly staged on site and exposed to weather and elements.
